# **Australian Char**

## **Bushfire Mitigation Plan 2026**

### **Electricity Safety (Bushfire Mitigation) Regulations 2023**

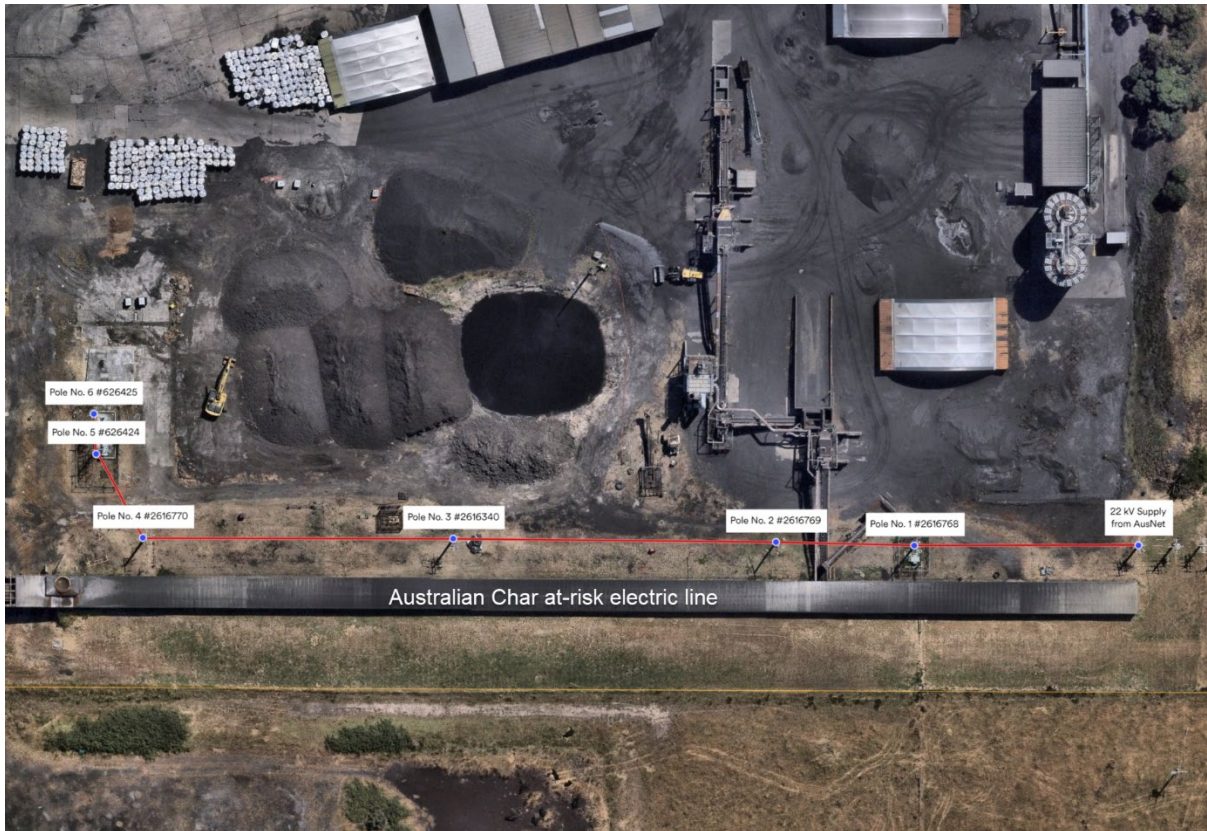
(Figure 2 – Image detailing Australian Chars’ at-risk electric line)

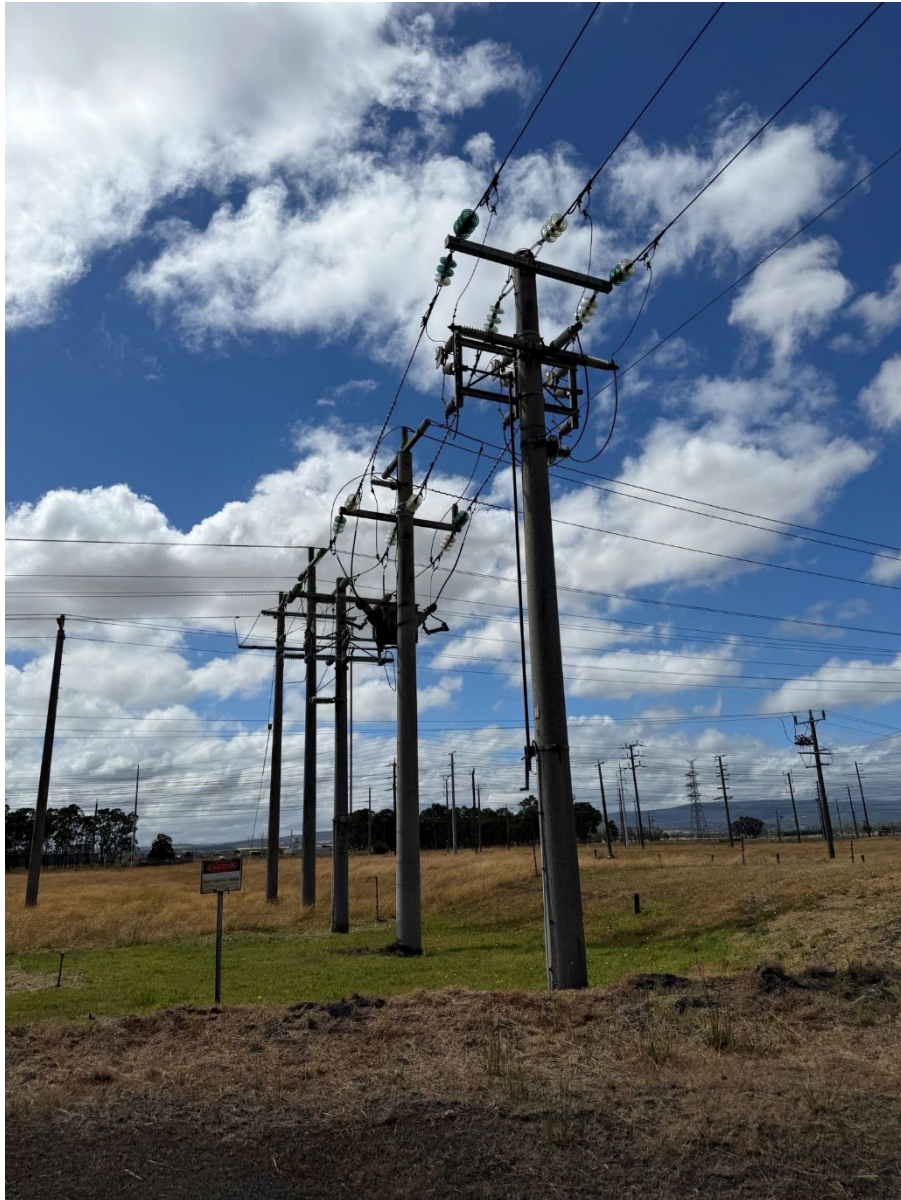
1. AusNet concrete pole (point of supply with air-break switch) Pole # 2616767 – outside Australian Char ownership but interface point.

The HV installation at Australian Char Morwell consist of a 22 kV aerial HV system running from the Ausnet pole #2616767 situated just inside Australian Chars property.

The AusNet feeder to AusNet pole 2616767 (point of supply) is protected by an upstream auto-recloser set to 3 reclose attempts before lockout.

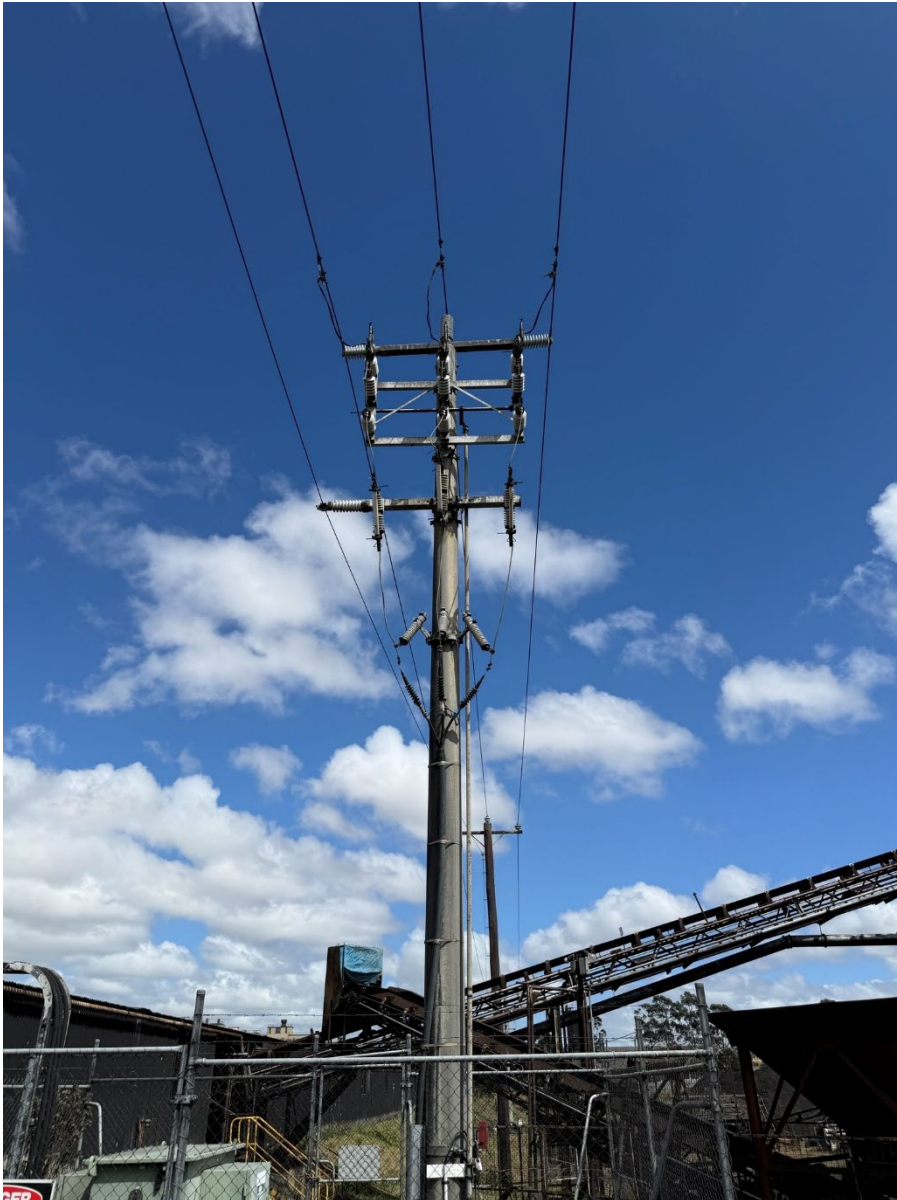
2. Australian Char concrete pole No. 1 #2616768 – air-break switch + HV drop-out fuses + pad-mounted oil-filled transformer (bundled).

Aerial conductors run to pole 1 (2616768) of the HV installation. This is a concrete pole with an air break switch and HV powder filled drop out fuses mounted on it. The HV powder filled drop out fuses provide the short circuit protection for the oil filled pad mounted transformer. These fuses are connected to a three core XLPE cable that runs down the pole to the pad mounted transformer located at the base of the concrete pole. The pad mounted oil filled transformer is contained in a concrete bund.

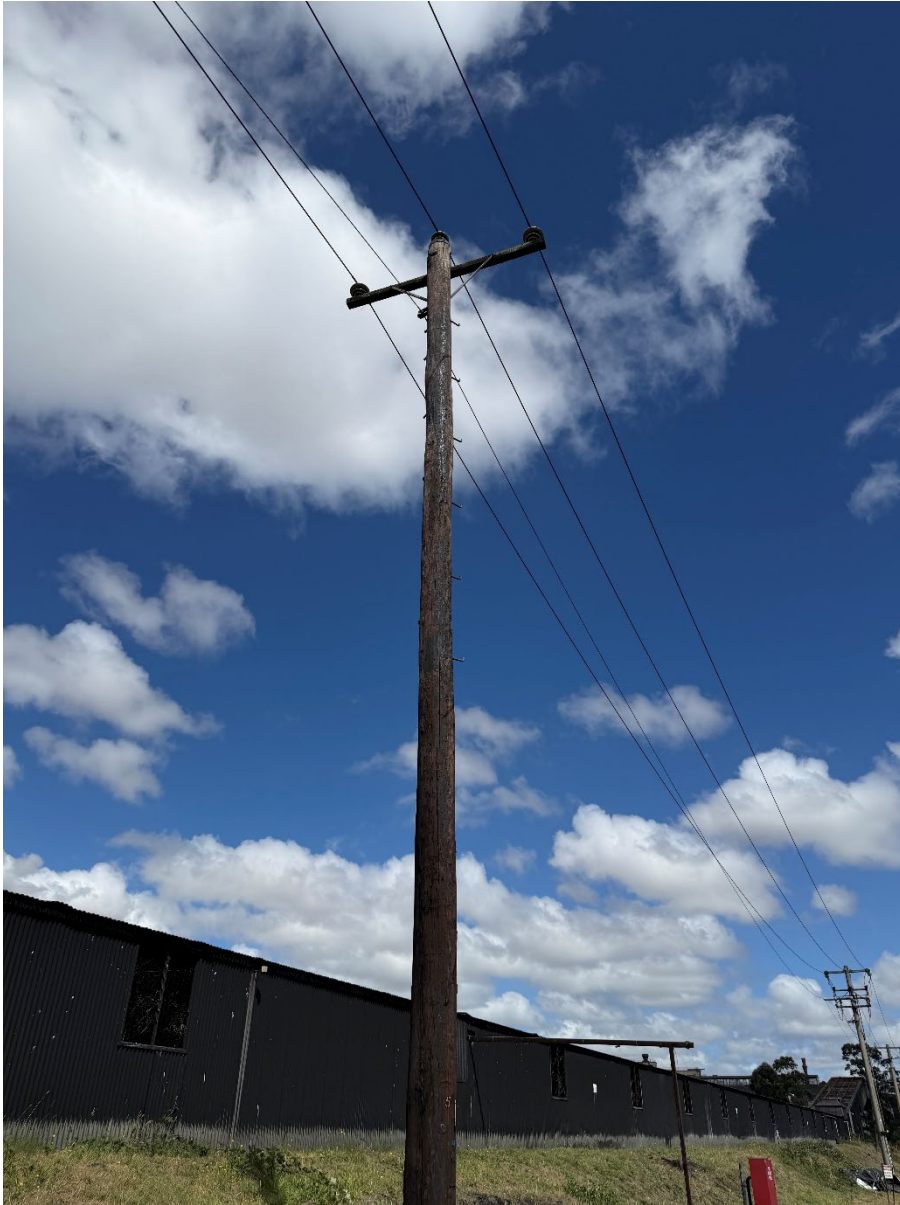
3. Wooden pole No. 2. #2616769 (Proposed for removal)

The aerial conductors then continue to pole 2 (2616769). This pole is a wooden pole.

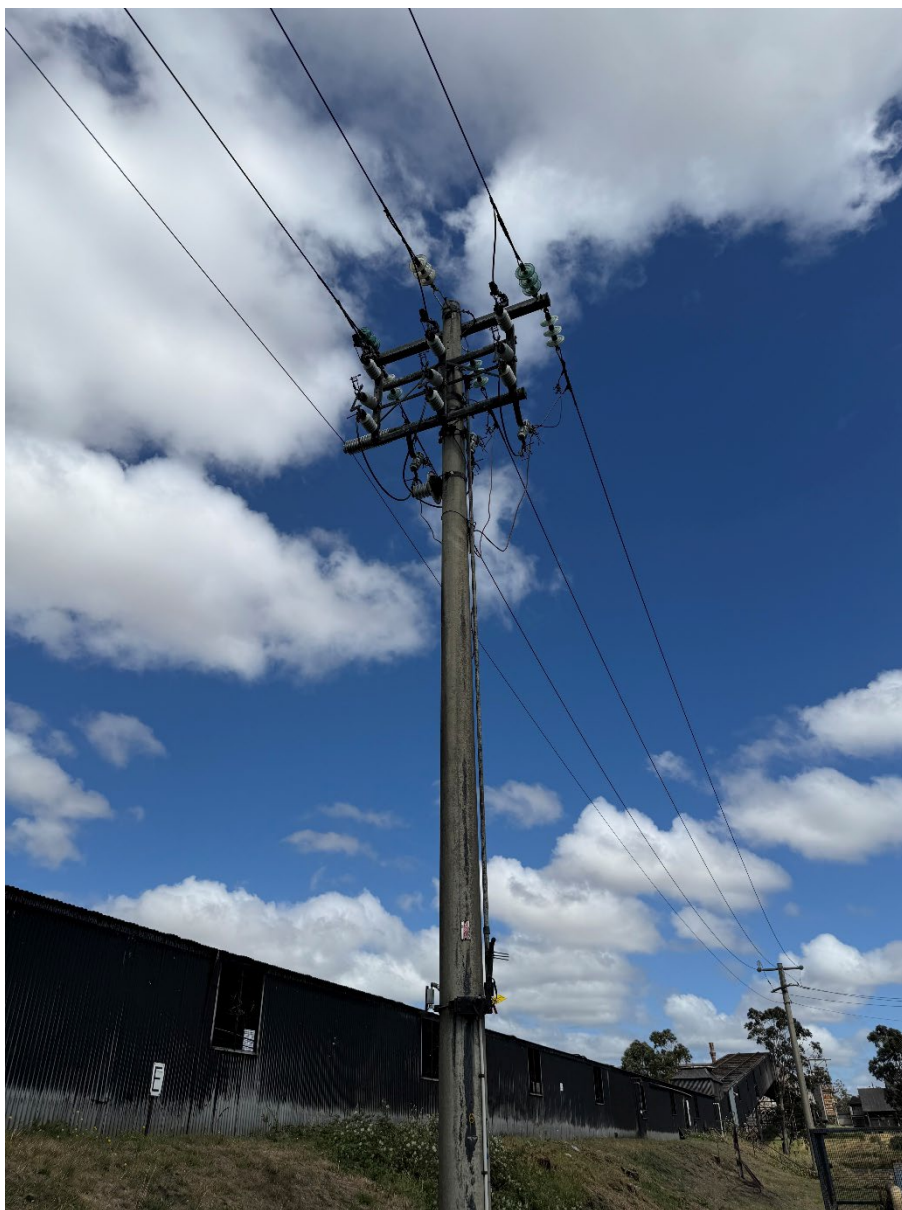
4. Concrete pole No. 3. #2616340 – air-break switch. (Proposed for removal)

Aerial conductors continue to pole 3 (2616340) which is concrete and has an air break switch and HV powder filled drop out fuses mounted on it.

The air break switch on Pole 3 has been opened and earthed, cutting supply to the remaining assets.

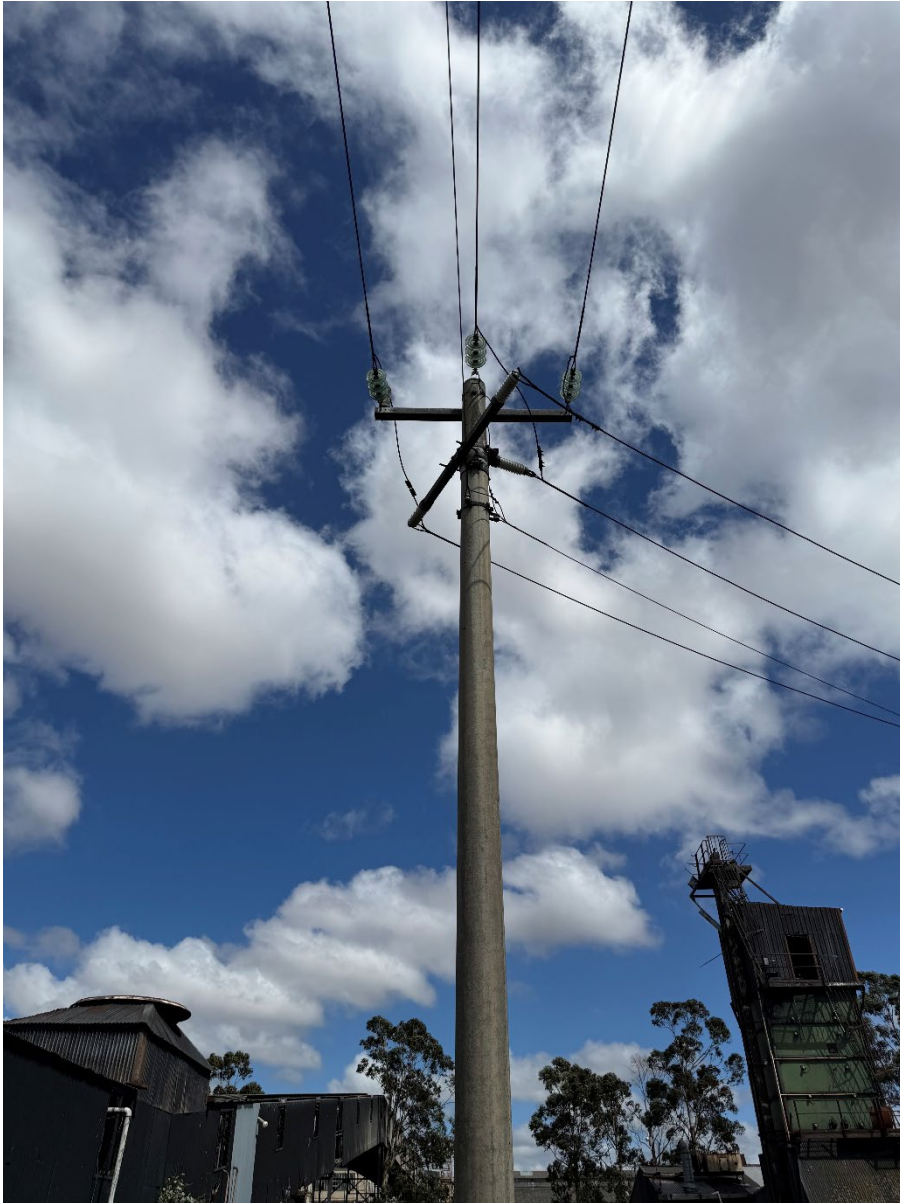
5. Pole 4. #2616770 (Proposed for removal)

The aerial conductors then continue onto pole 4 (2616770) which is concrete.

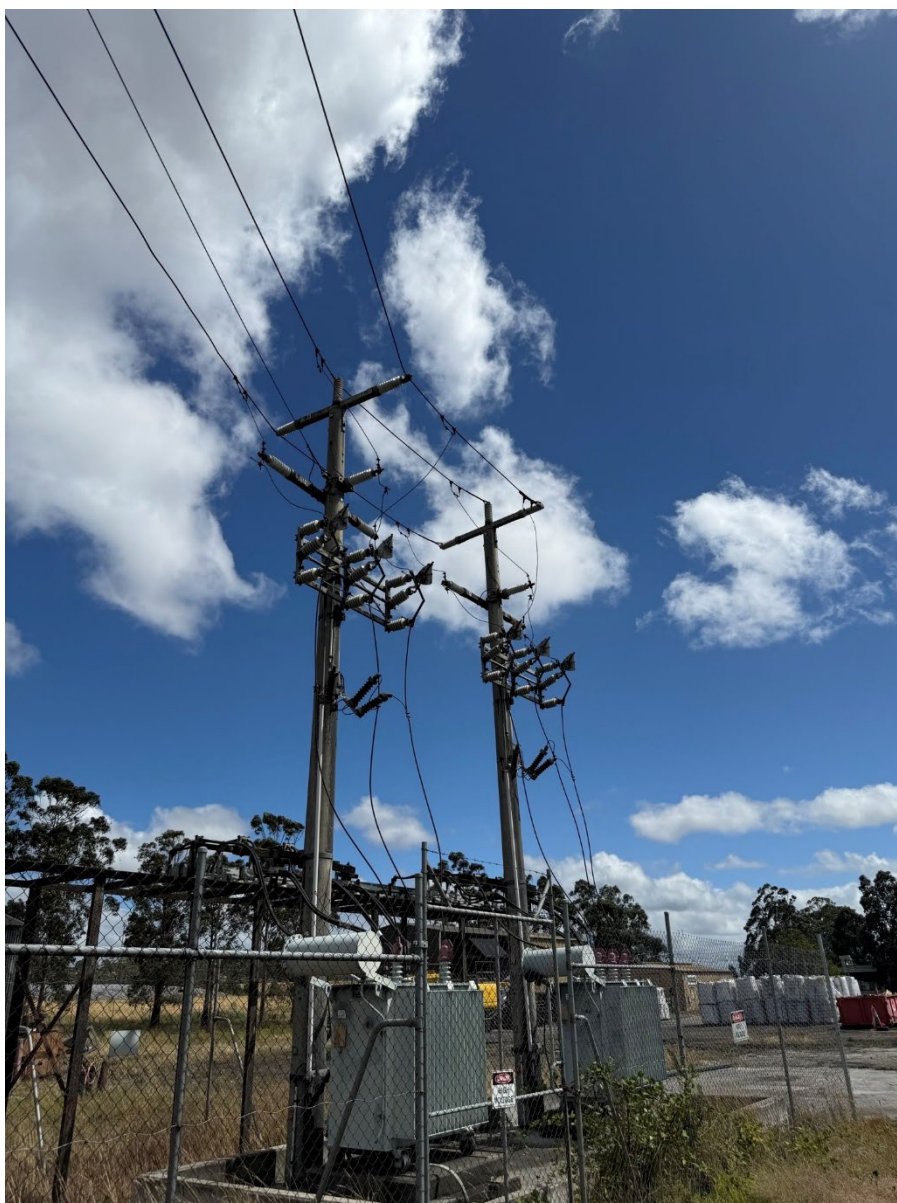
6. Concrete pole No. 5 #626424 and pole No. 6 #626425 (proposed for removal) – air-break switches + drop-out fuses + two pad-mounted oil-filled transformers.

Poles 5 (626424) and pole 6 (626425) are concrete. These poles have air break switches mounted to them and each pole is connected to separate pad-mounted oil-filled transformers by bare cables.
